*Preserving  
the past.*

*A study  
in church  
restoration.*

*The Benedictine Chapel of Perpetual Adoration*  
*Clyde, Missouri*

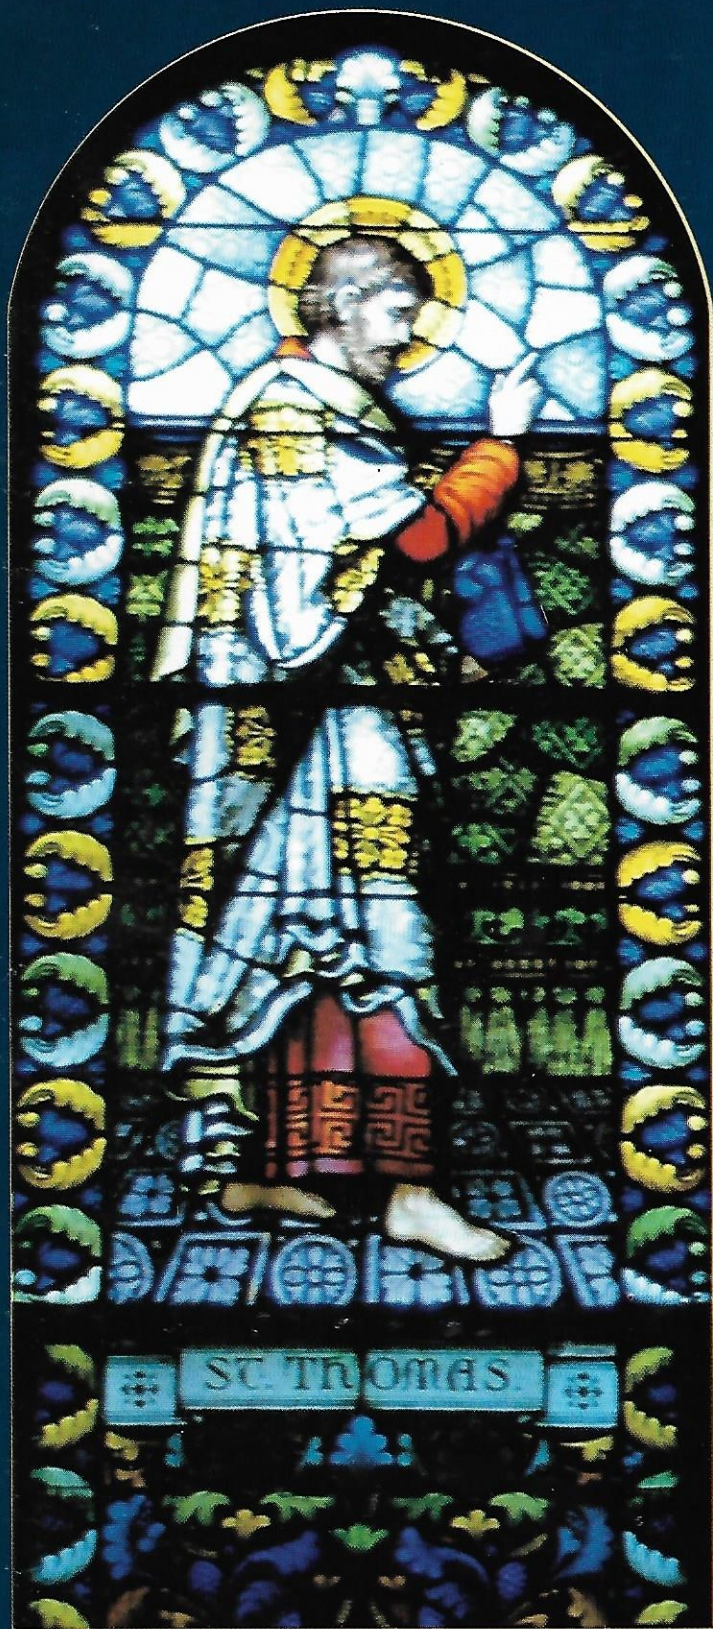
The majestic stained glass windows, also produced by the Tyrolese Art Glass Company, represent some of the apostles and evangelists, each displaying the instrument of his martyrdom.

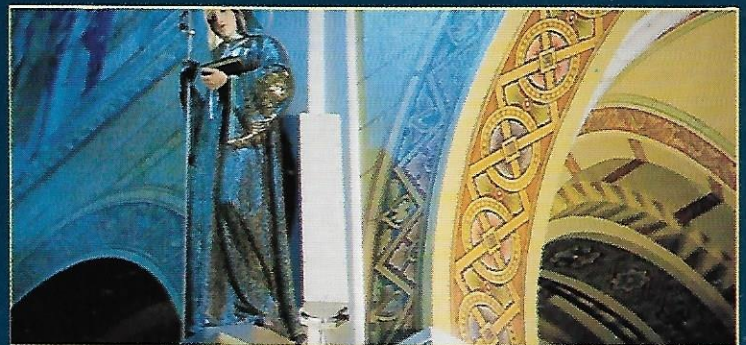
Statues of Benedictine women saints face the nave or center section of the chapel. These include St. Scholastica, St. Hildegard, St. Gertrude and St. Walburga. Each figure is shown with a distinctive symbol characterizing her life.

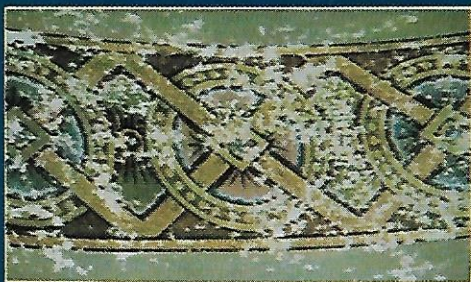
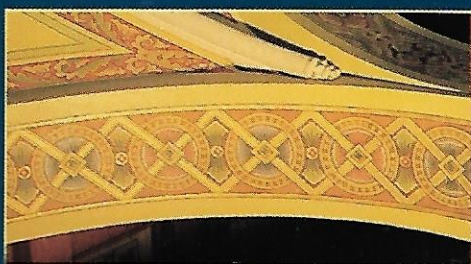
The six man crew of Church Decorating and Design often worked 10 and 12-hour days during the five month restoration project. The work was sometimes almost hypnotizing in sheer scope and complexity. Wall, ceilings, arches, window ledges—virtually every chapel surface was cleaned by hand before repair and repainting was done. If the original designs and patterns were in good shape, they were left intact. If they

were salvable, they were retouched. If they were badly deteriorated or obliterated, they were painstakingly recreated. Colors were matched, delicate shadings were duplicated—fully 80% of the restored design work was done freehand with artist brushes. The Sisters of the Community were always at hand, and often helped decide whether or not a certain color had “just the right tint” that would match the original.
